RE: **BUILDING DEMOLITION REVIEW**  
**197 Seymour Street (MAP 5, Lot 105)**  
**Circa 1934, one-story wood framed residential structure and 1984 two story addition.**

# CLUNIE ENGINEERING

Subject: Inspection of Residential Building and Garage  
197 Seymour Street, New Bedford, MA

INSPECTION OF BUILDING AT 197 SEYMOUR STREET, NEW BEDFORD, MA

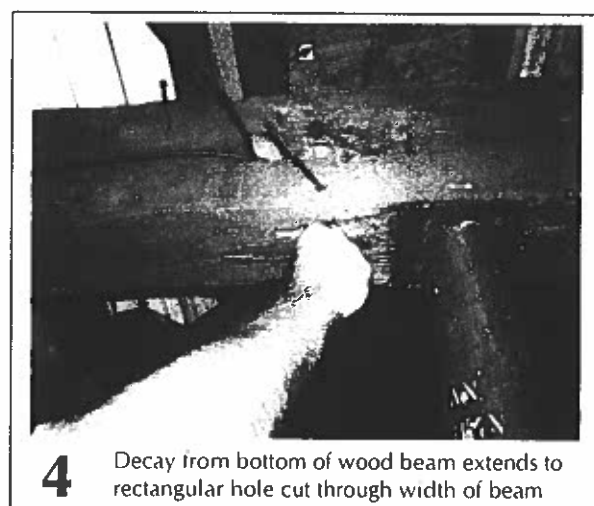
1. As shown and described in Photos 1 through 4 on Page 3 herein, the wood beam that supports the first floor joists in the basement of the front building ell has sustained various deterioration and damage. Some areas are decayed and split, while other areas contain rectangular holes that were cut through the entire width of the beam. Such a significant reduction of the load capacity of this approximately 30-foot long beam will likely necessitate that it be replaced.

Due to conditions outlined above, it is not feasible to proceed with the work as is currently proposed and budgeted. Work required to replace the beam identified in Item 1 above will be extensive and correspondingly expensive, and it may prove to be the same for whatever work may be required for roof rafters and/or knee walls and/or floor joists as described in Item 2 above.

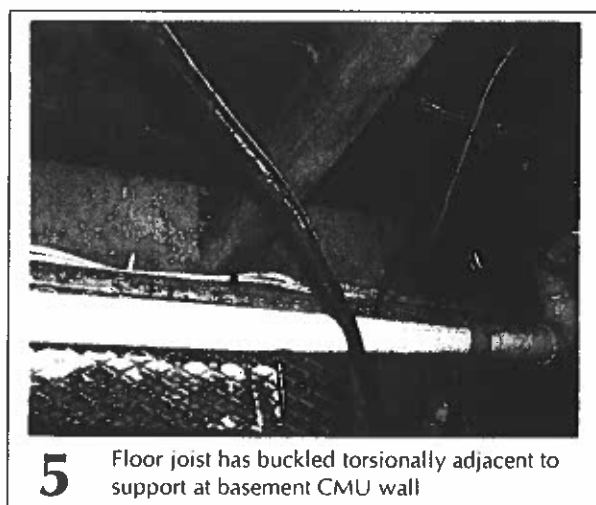
Photos 5 and 6 on Page 3 also show several joists and subflooring boards that must be replaced, which are representative of similar work elsewhere. All of this work will require engineering design and construction control in addition to the cost of construction.

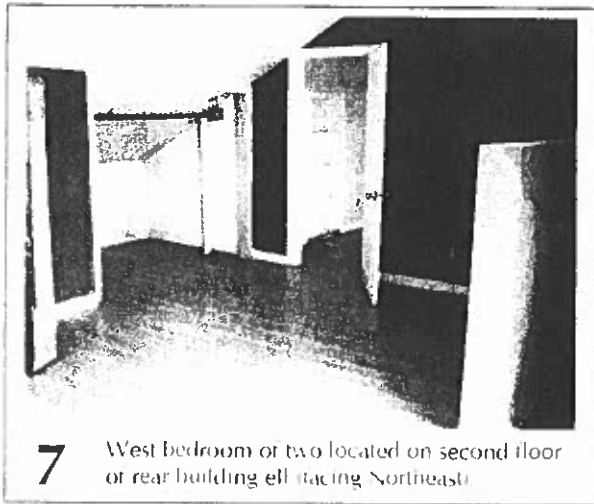
**7** West bedroom or two located on second floor of rear building ell facing Northeast

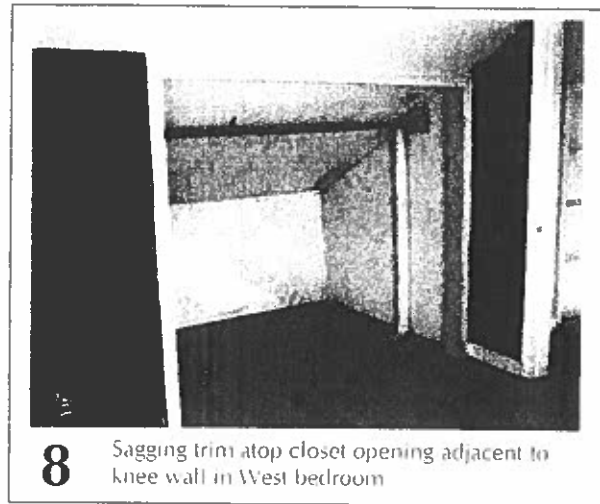
2. I have included Photos 7 through 11 on Page 4 herein to try to address what I anticipate may be problems with some structural components in the rear building ell that were inaccessible for inspection because they are concealed. The sagging curve of trim and wall above each of the two closet openings in the knee wall near the rear of the building indicates the possibility of problems with the load transfer along the load path between roof rafters and knee walls and second floor joists. Further investigation would be required, which would necessitate localized exploratory demolition and engineering calculation to analyze components.

**8** Sagging trim atop closet opening adjacent to knee wall in West bedroom

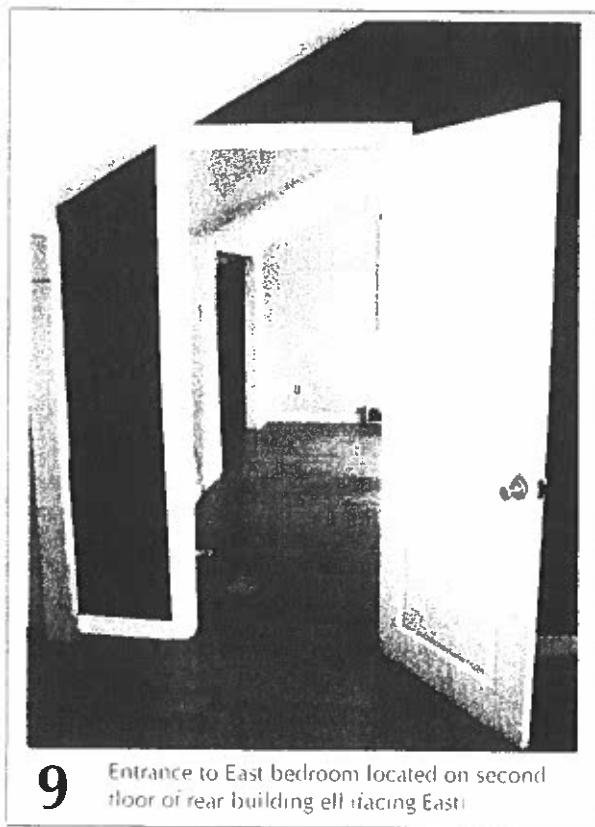
**9** Entrance to East bedroom located on second floor of rear building ell facing East

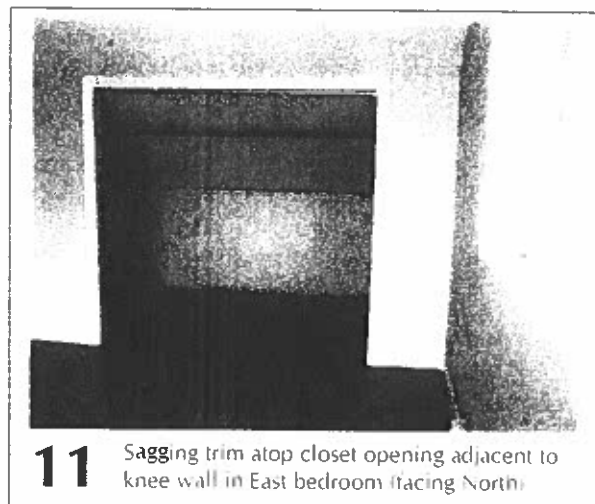
**11** Sagging trim atop closet opening adjacent to knee wall in East bedroom facing North
