RE: 115, 117, 121 Union Street Demolition

April 14, 2021

SE Project NBDC-221-01
Existing Conditions Assessment
121, 117 & 115 Union Street
7 North 2nd Street
New Bedford, MA

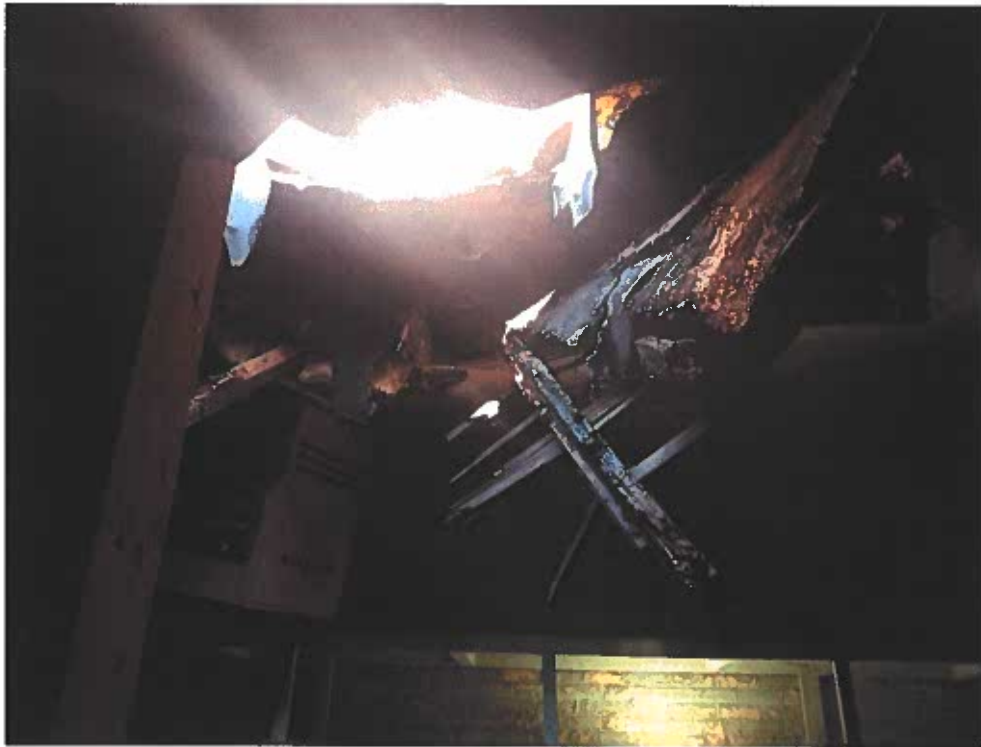
1. The roof framing at the back of the building has collapsed (Photo #1). ***The roof is adjacent to the 3-story building, which causes drifting on to the lower roof. The roof appears to be deteriorated, which is caused by water intrusion thru the roofing membrane. It appears the combination of deteriorated wood framing an overstressing from snow drifting has cause the roof to collapse.***
2. The steel framing and wood framing is severely deteriorated at the front façade of the building (Photo #2 & 3). ***The severe deterioration is causing the entire front façade to pull away from the building approximately 1" (Photo #4, 5 & 6) and will ultimately fall onto the pedestrian sidewalk.***
3. The interior steel girders and columns are severely deteriorated (Photo #7 & 8). ***The deteriorated steel may become overstressed, causing the ceiling to collapse.***

Photo #1 – Roof collapse at the back of the building adjacent to the 3-Story Building.

- Buildings 121 Union Street, 117 Union Street, 115 Union Street and 7 North 2nd Street should be demolished before the deterioration progresses further and causes harm to the public. The existing adjacent buildings should be reviewed and shored as necessary during the demolition process.
- The masonry façade on the 3-story building should be repointed and retrofitted by a professional mason.

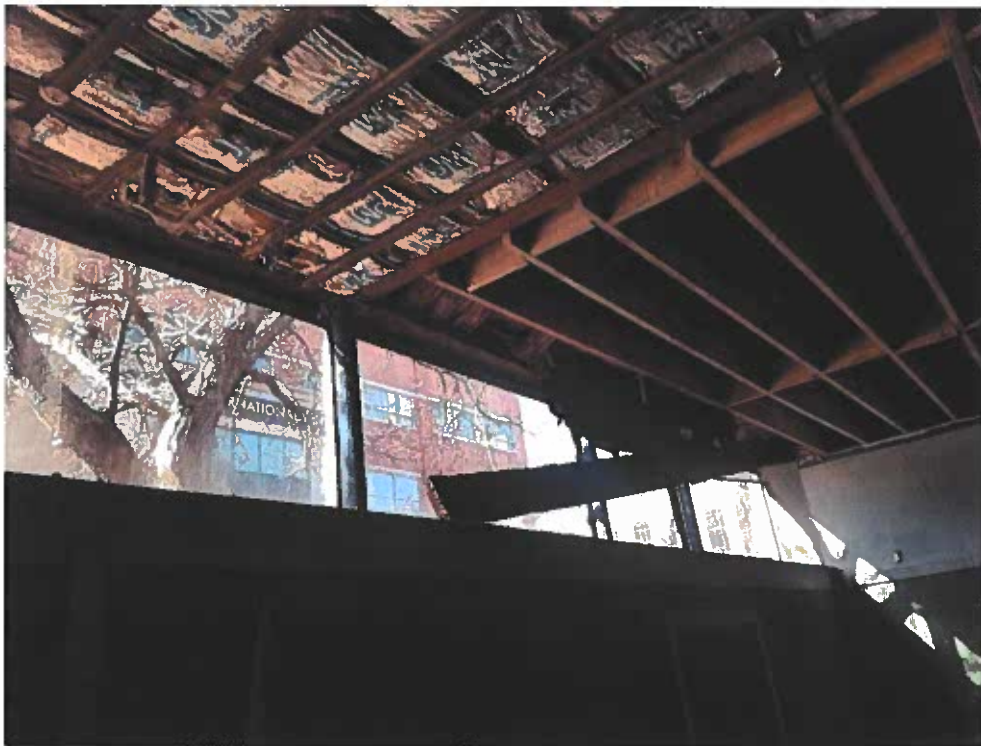
Photo #2 – Steel girder, perimeter steel lintel assembly and wood framing deteriorated at front façade.

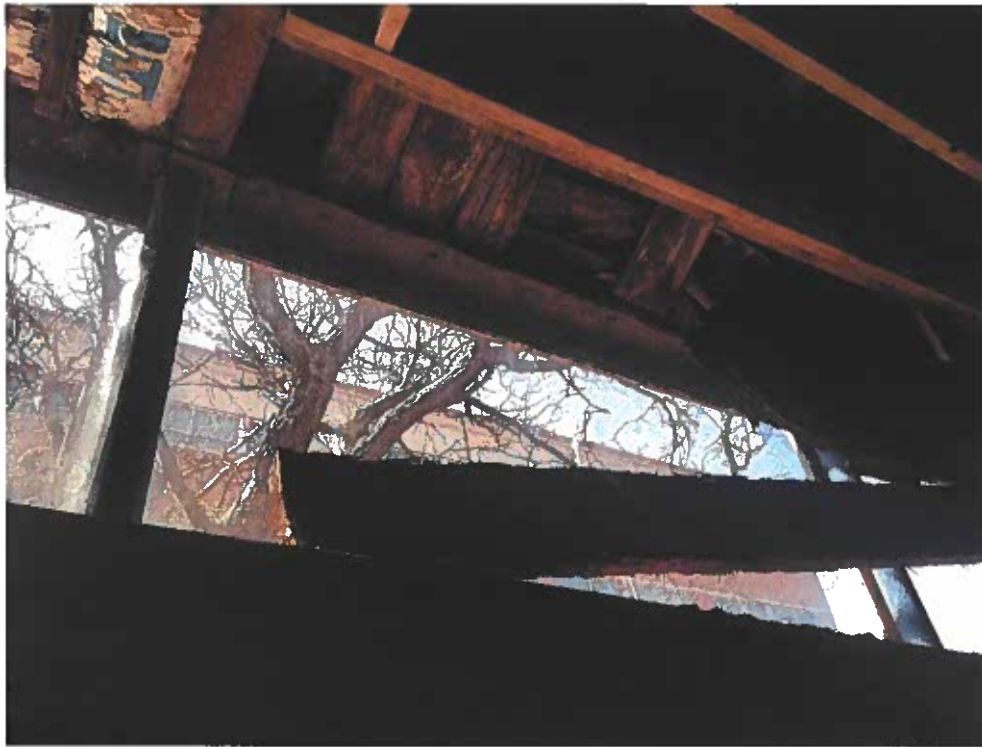
Photo #3 – Steel girder, perimeter steel lintel assembly and wood framing deteriorated at front façade.

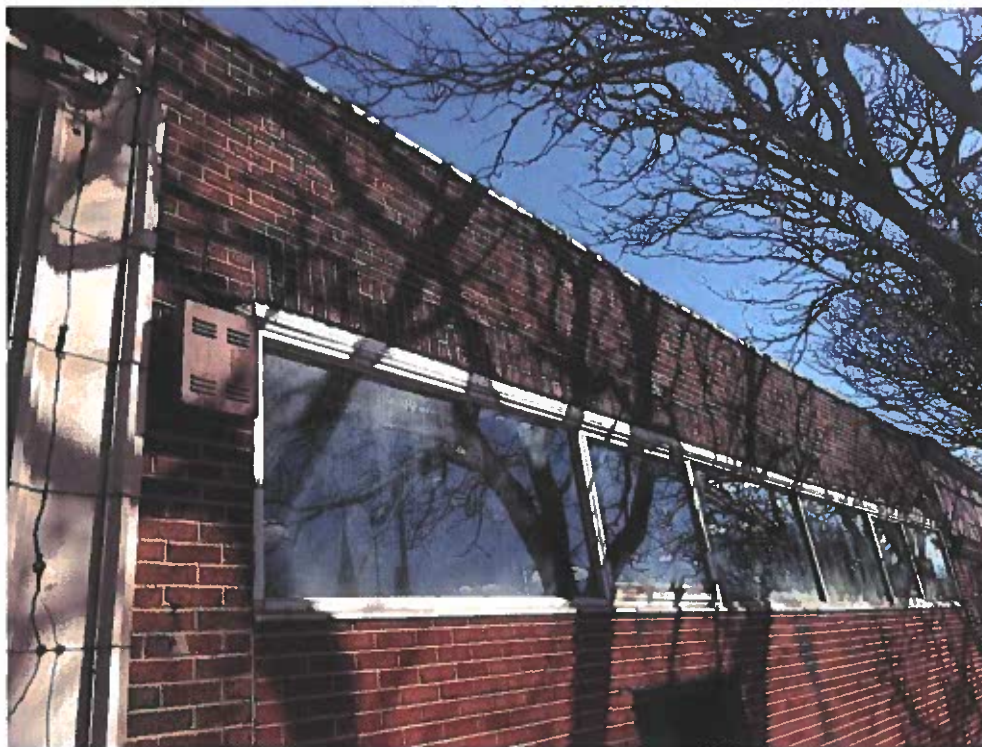
Photo #4 – Front façade pulling away from the building at the failed lintel assembly.

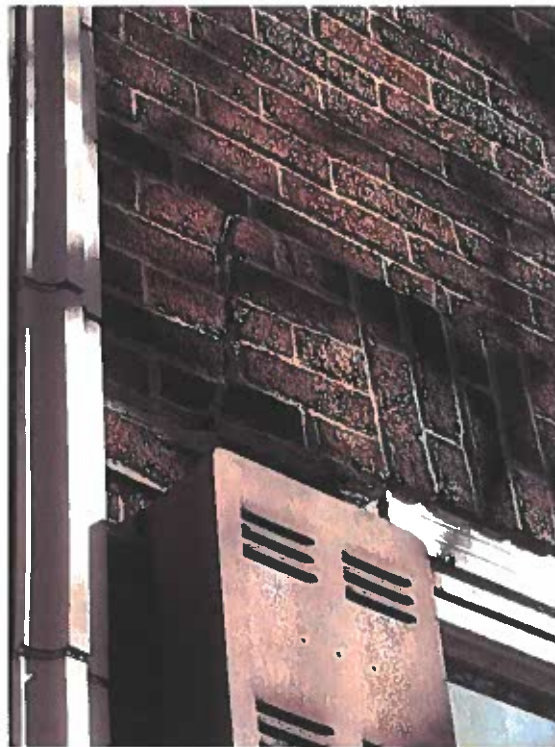
Photo #5 – Façade pulled away from the building approximately 1”.

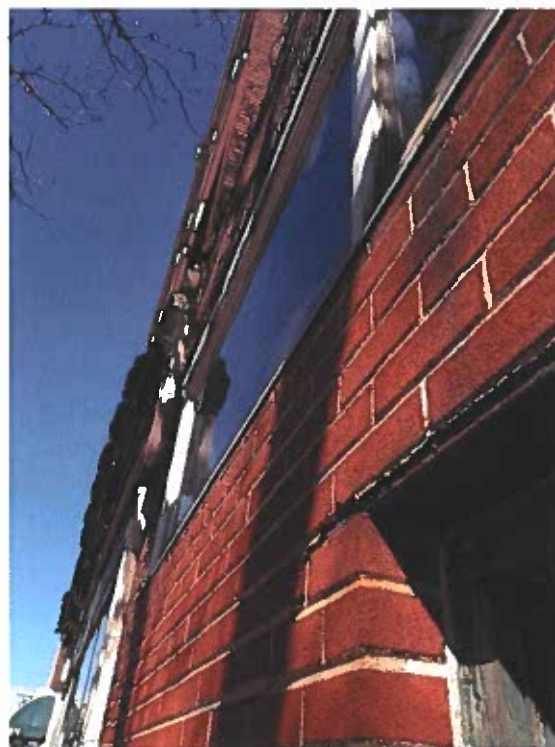
Photo #6 – Façade pulled away from the door lintel approximately 1”.

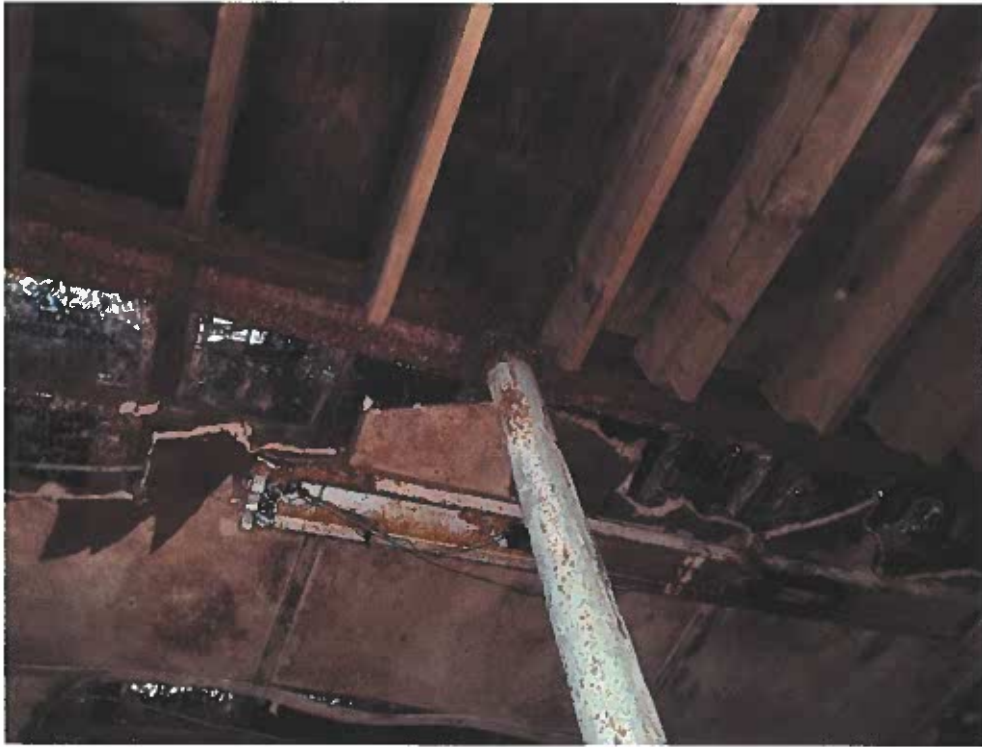
Photo #7 – Steel girders and columns severely deteriorated.

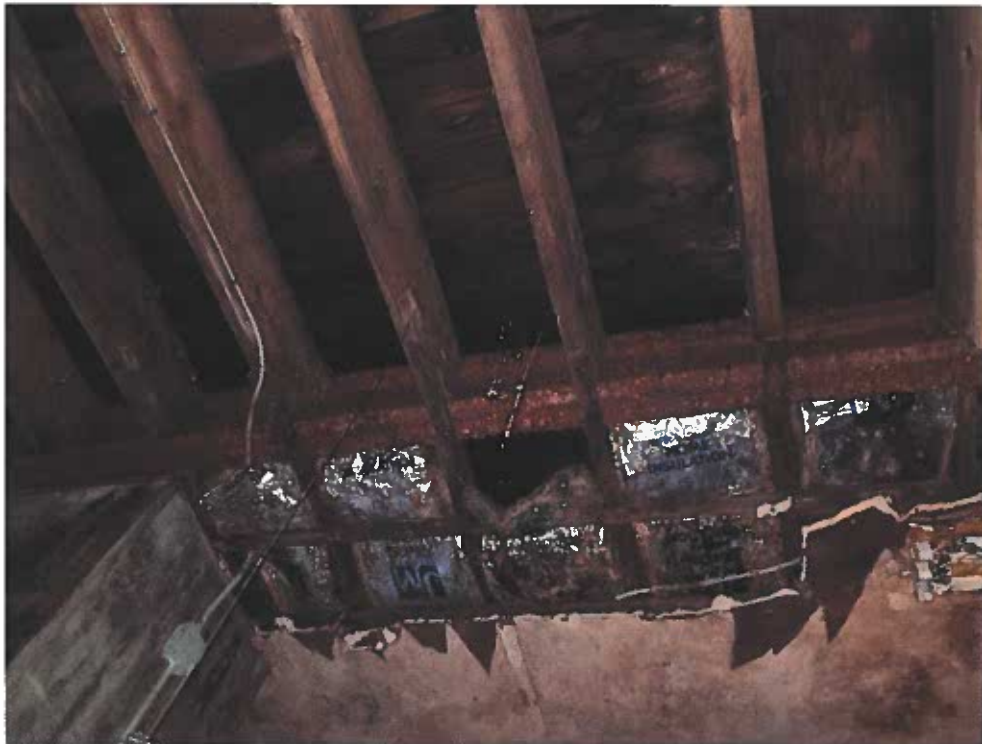
Photo #8 – Severe deterioration of the steel framing.

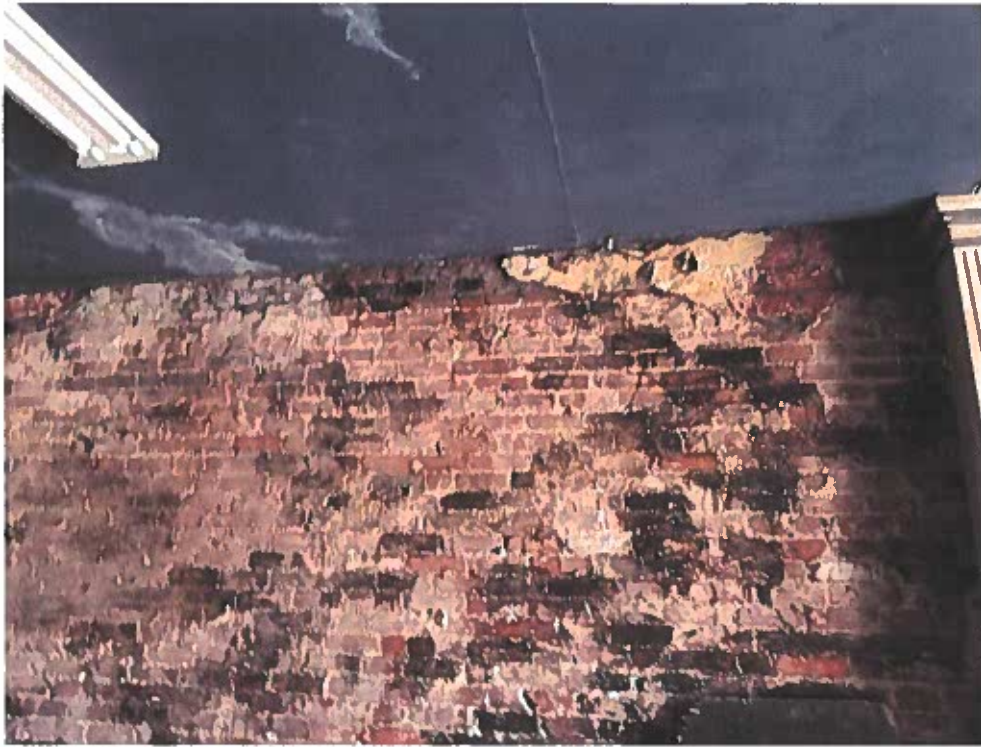
1. The back wall and ceiling showed signs of water intrusion (Photo #9). ***The water intrusion is most likely deteriorating the concealed wood framing, which would cause a roof collapse. The mortar is deteriorated and adversely affecting the structural integrity of the bearing wall.***
2. The lintel assembly is failing at the front and side of the building. The masonry wall is pulling away from the structure at the front of the building (Photo #10, 11, 12 & 13). The lintels are excessively deflecting, and the masonry has diagonal cracks coming from the failing lintels (Photo #14, 15 & 16). ***The failing lintel assembly is causing the perimeter masonry walls to become unstable and detached, which will ultimately fall onto the pedestrian sidewalk.***

Photo #9 – Water intrusion at the back wall.

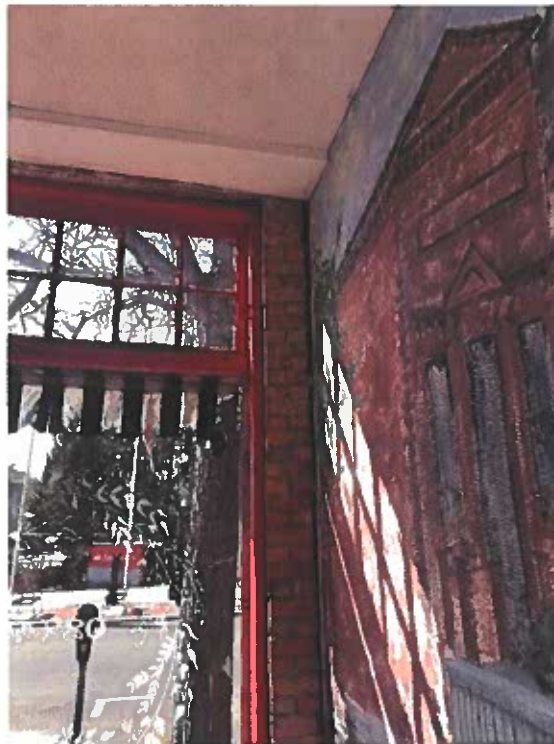
Photo #10 – The front façade is pulling away from the structure.

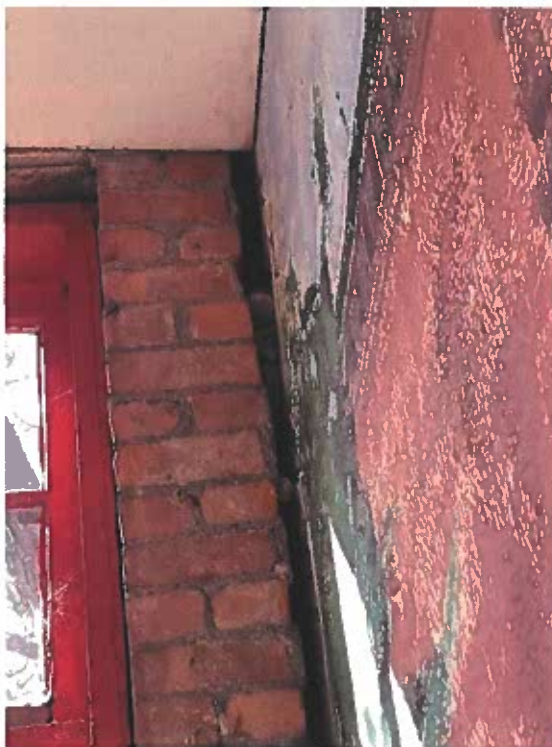
Photo #11 – Daylight can be seen from the masonry pulling away from the structure.

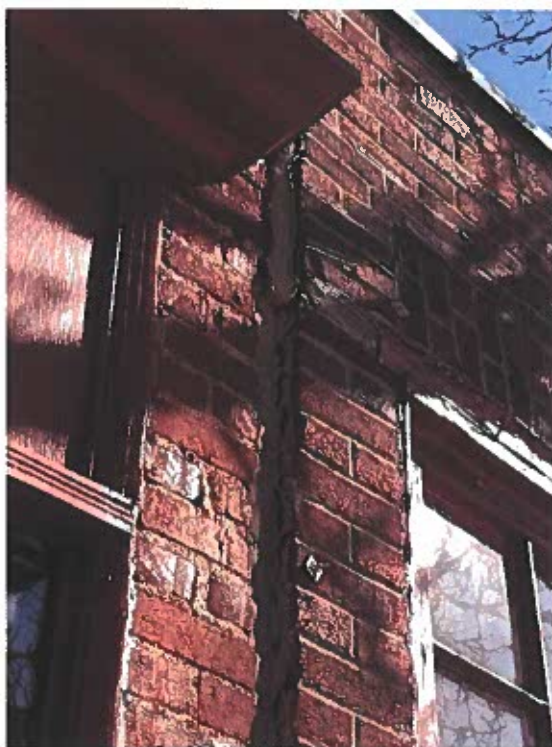
Photo #12 – Masonry wall pulling away from the front of the structure approximately 2".

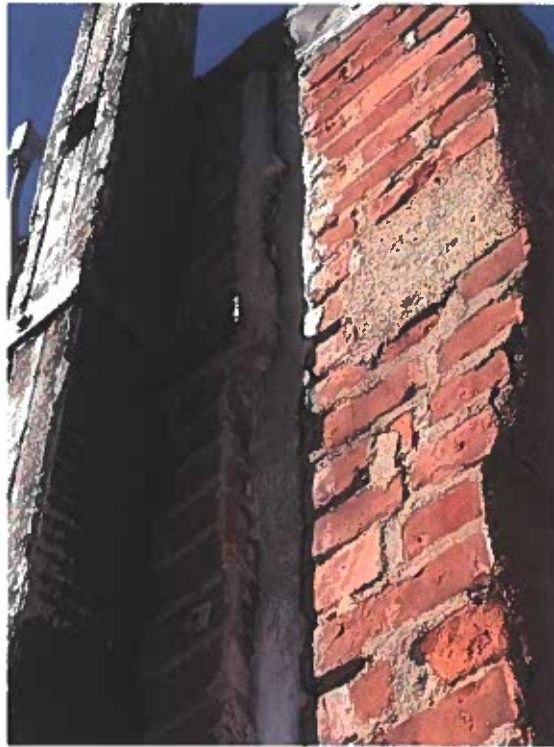
Photo #13 – Masonry wall pulling away from the back of the structure approximately 2”.

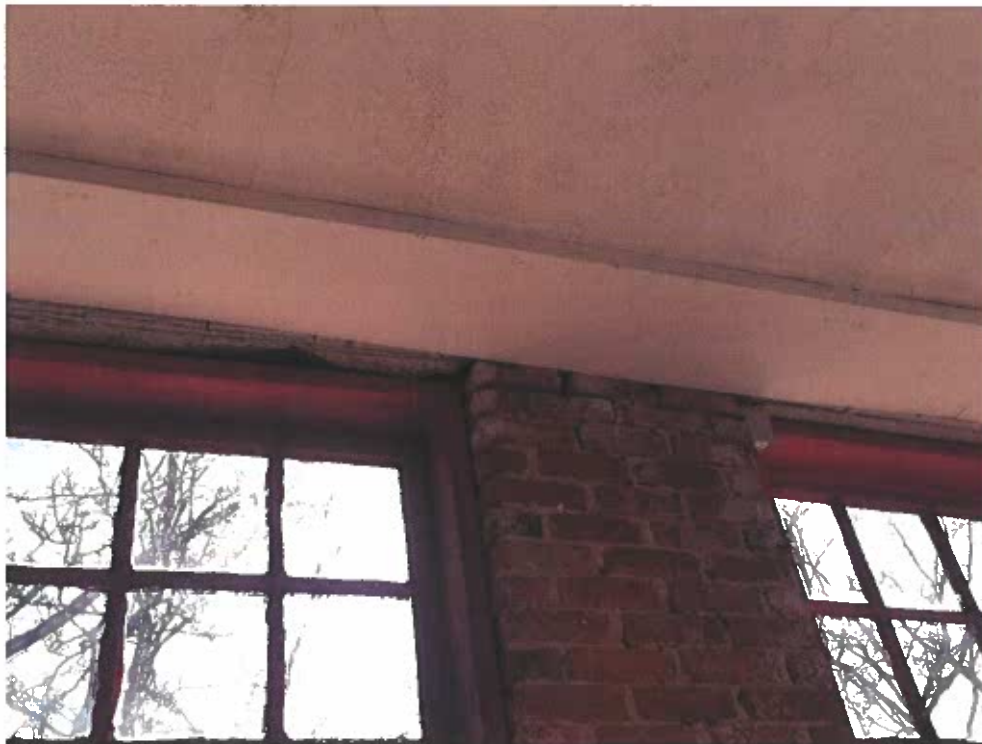
Photo #14 – Lintels excessively deflecting and the masonry deteriorated at the supports.

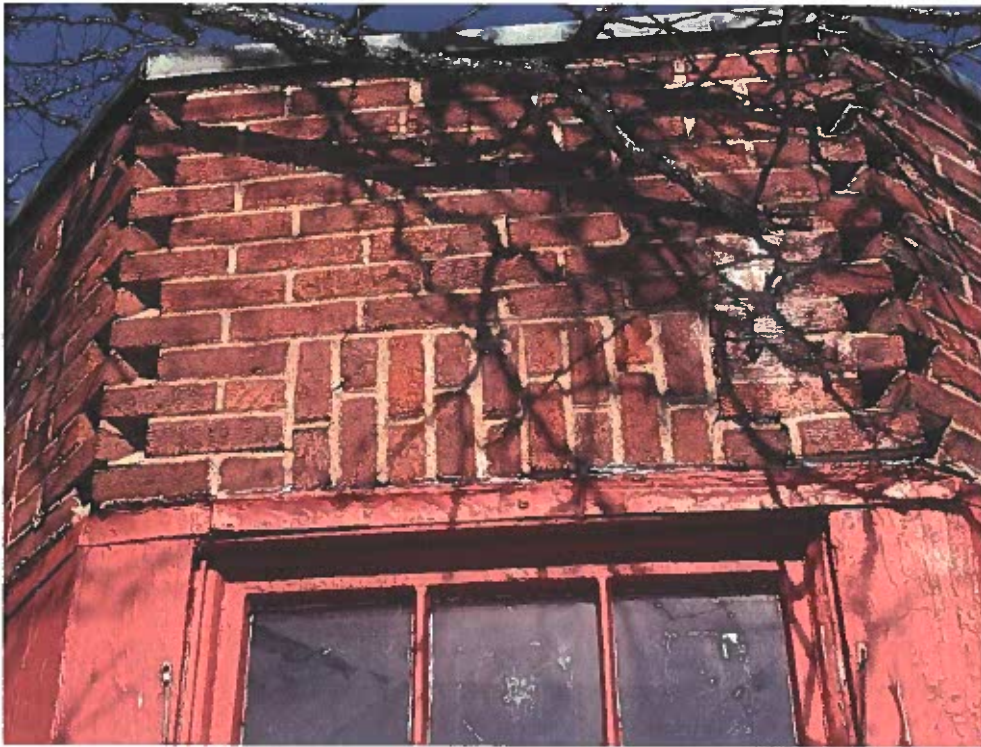
Photo #15 – Diagonal cracking above front lintel assembly.

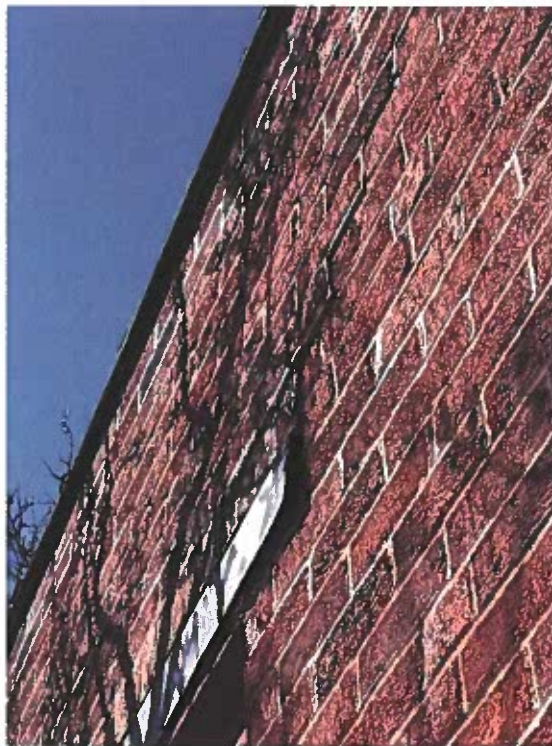
Photo #16 – Diagonal cracking and pulling away from the structure at the side lintel assembly.

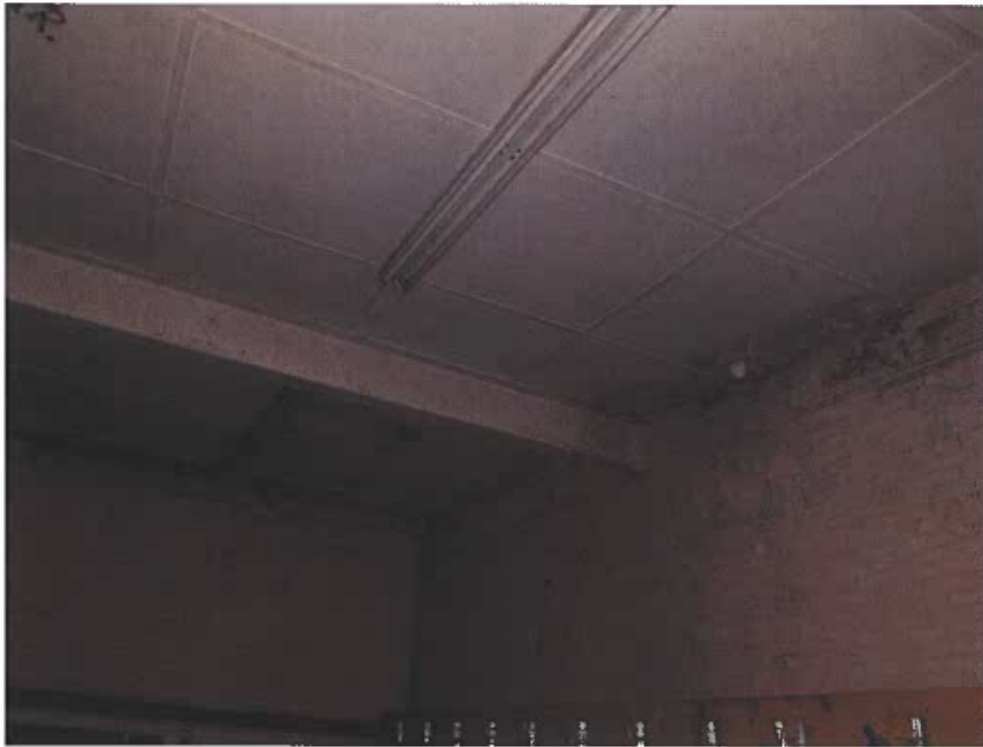
1. Water intrusion on the roof at the front and back of the building (Photo #17 & 18). ***The water intrusion is most likely deteriorating the concealed wood framing, which would cause a roof collapse.***
2. The side wall has a deteriorated gutter, with no downspouts, and water has been eroding the mortar of the masonry bearing wall (Photo #19). The location of the deteriorated masonry wall is supporting a steel beam (Photo #20). ***The deteriorated masonry wall is spalling and has lost the structural integrity to support the steel beam, which will ultimately cause the roof to collapse.***

Photo #17 – Water intrusion at the front of the building, adjacent to 121 Union street.

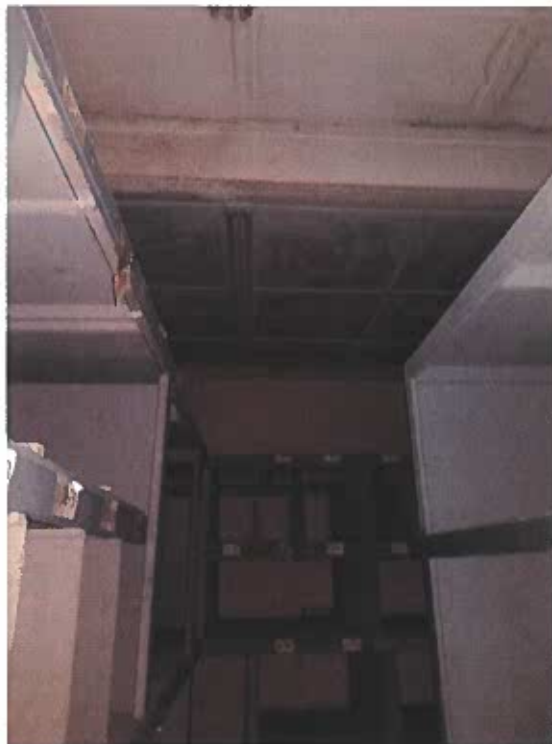
Photo #18 – Water intrusion at the back of the building.

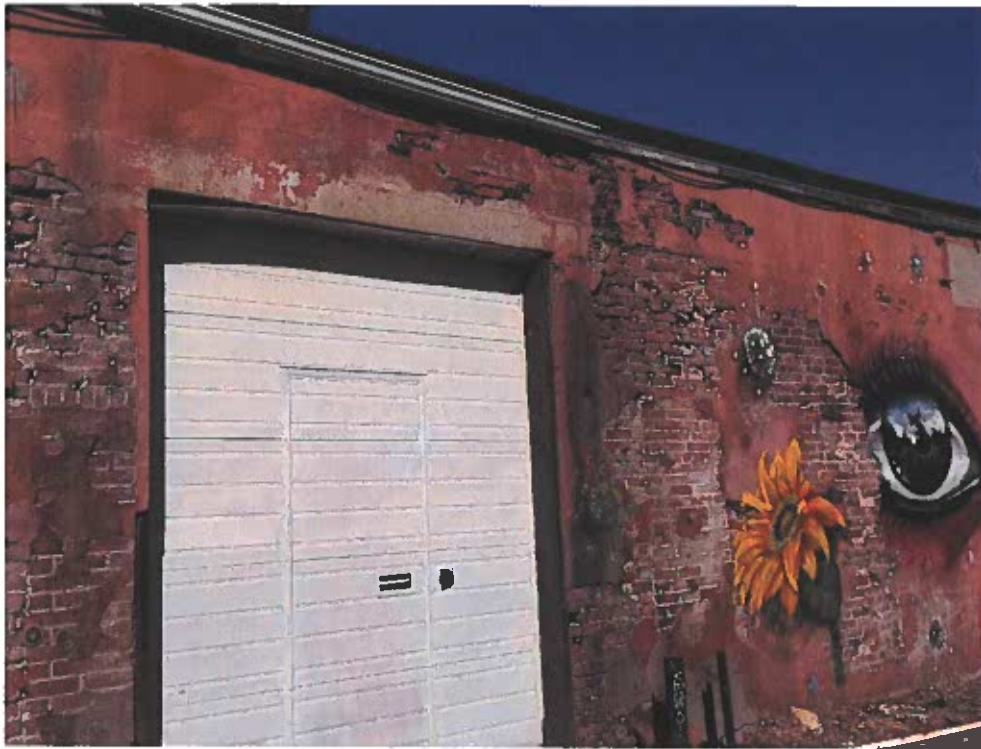
Photo #19 – Gutter above overhead door with no downspout.

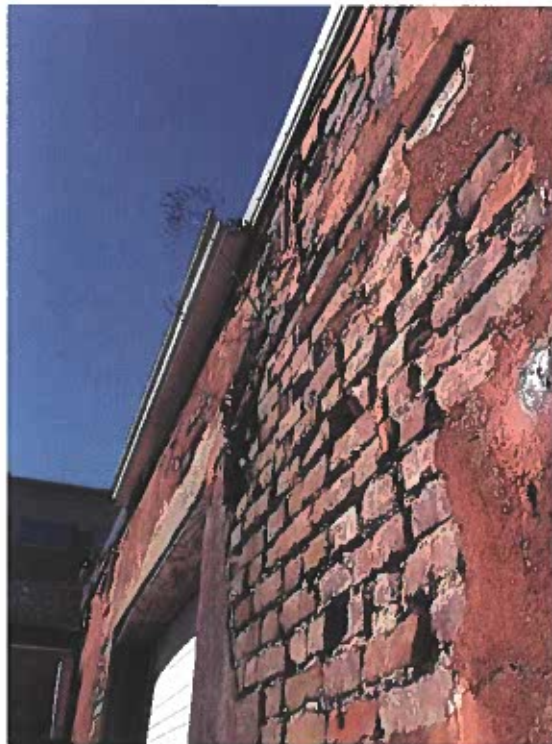
Photo #20 – Water eroded the mortar directly below a beam and causing wall instability at the support.

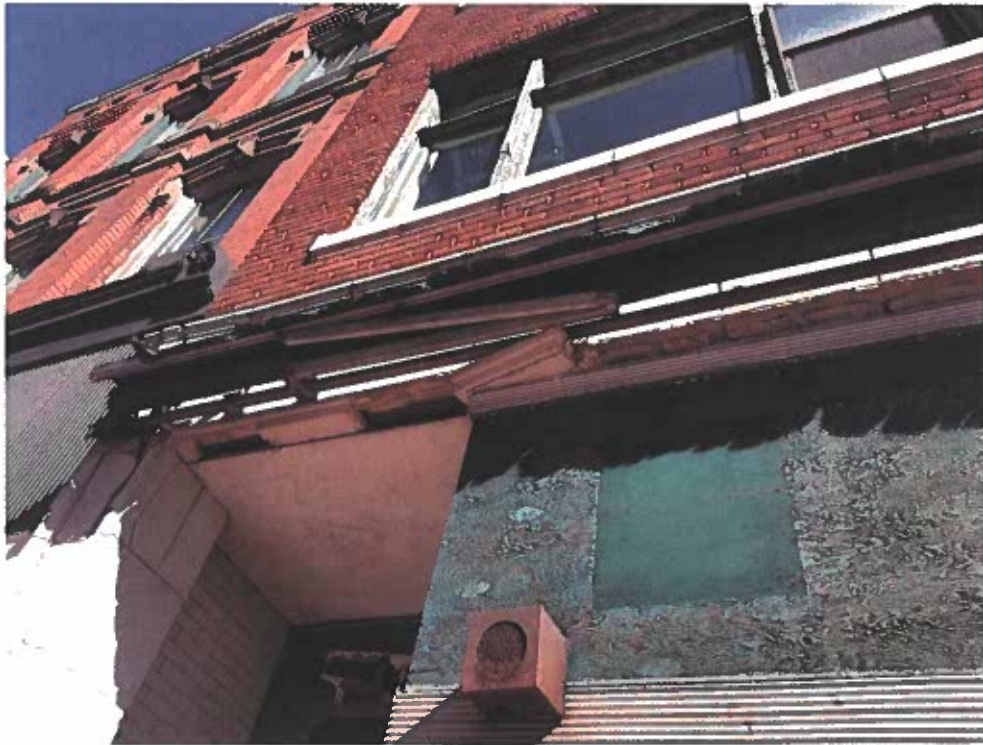
1. We did not perform an inspection of the 3-story building adjacent to 121 Union Street, but we noticed that the masonry band along the front façade is severely deteriorated and spalling (Photo #21 & 22). ***The deteriorated masonry is spalling onto the pedestrian sidewalk.***
2. We walked thru the 3-Story building to get access to the 7 North 2nd Street building. We noticed that the back room, single story portion at the back of the building, showed signs of deterioration and the ceiling was collapsing adjacent to the masonry stack (Photo #23). ***The entire roof shows signs of water damage and it appears this roof is severely deteriorated and starting to collapse.***

Photo #21 – Masonry band is deteriorated and spalling off the building.

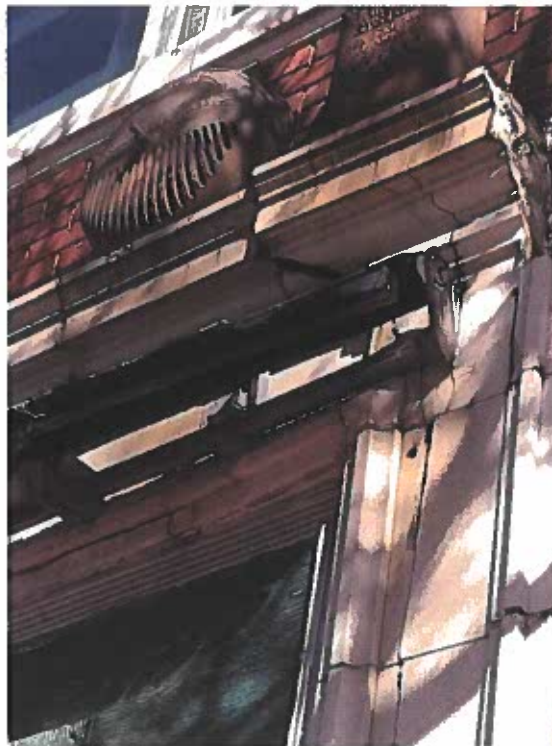
Photo #22 – Masonry band is deteriorated and spalling off the building.

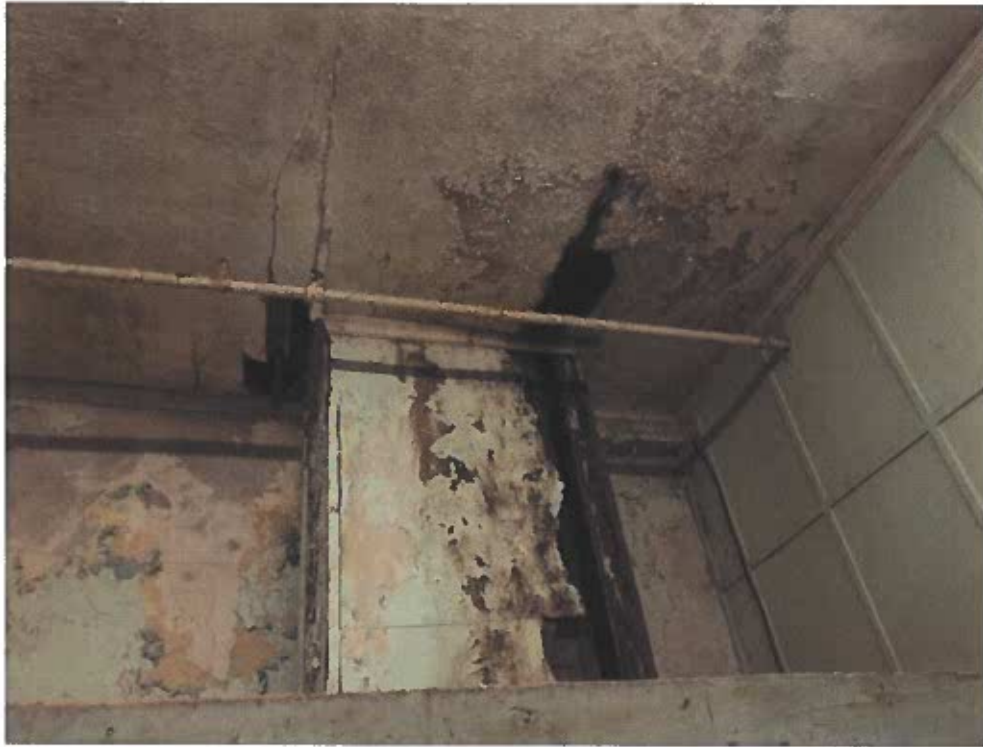
Photo #23 – The wood framing is deteriorated and starting to collapse.

- The single-story building, at the back of the 3-story building, should be demolished or shored up if it is to be retrofitted in the future.
