**RE: BUILDING DEMOLITION REVIEW**  
**1 Rear Coffin Avenue (Map 100 Lot 117) Circa 1902 masonry mill building**

**SURVEY BOARD REPORT FOR 1 R COFFIN AVENUE, NEW BEDFORD, MA**

**INSPECTION REPORT FOR 1 R COFFIN AVENUE, NEW BEDFORD, MA**

**BUILDING ROOF SURVEY AT 1 R COFFIN AVENUE, NEW BEDFORD, MA**

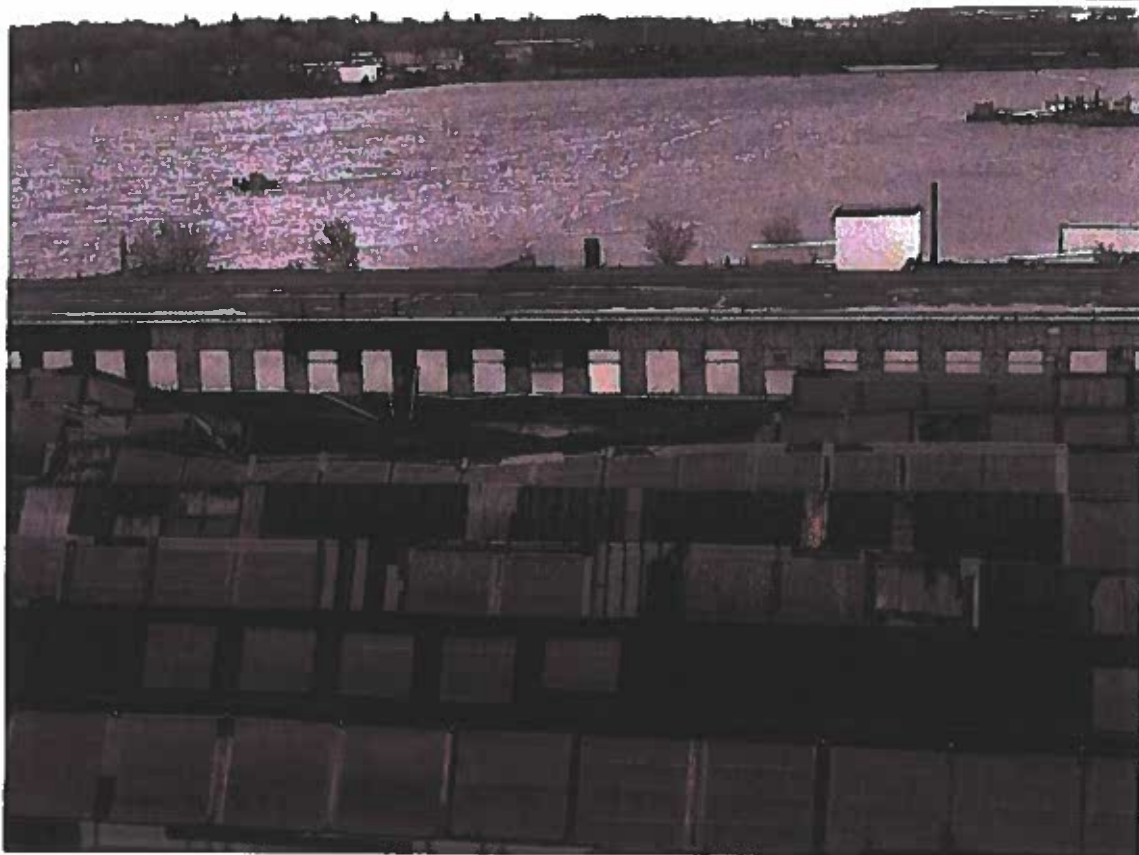
**9** Two bays of sawtooth roof systems located near the middle of the South end of the building have collapsed along approximately one-third of their 303 foot length from East-to-West (facing South) – ref. Photos 2 & 3

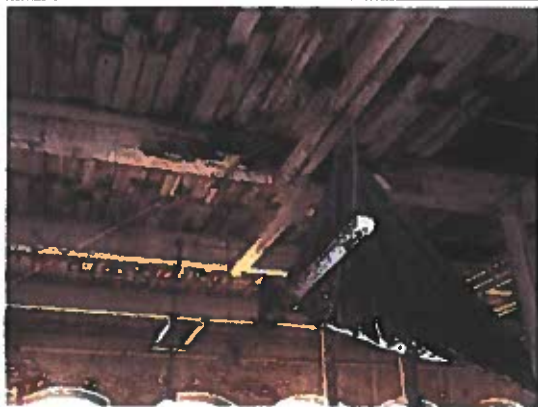
2. As shown in Photos 1 on Page 5 herein, water has stained roof sheathing boards over areas of the second floor at the South end of the building. Potential wood decay or mold propagation along the boards was not determined during inspection since no tactile examination of the boards was performed. Since the blue tarp that had been hung from the roof to collect water was dry, it appears that roof seepage has been arrested.

**1** Water-stained roof sheathing boards at South end of building (second floor facing South)

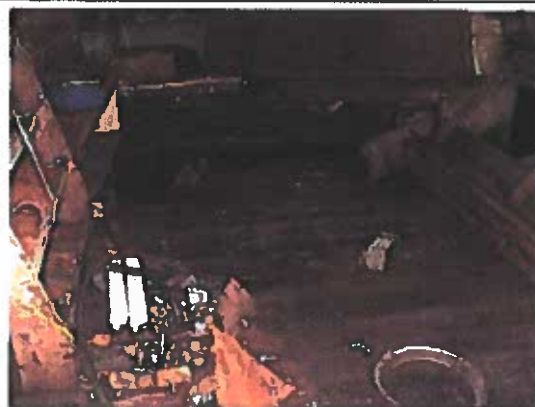
Photos 2 through 4 show water stains and wood decay at several areas of the finish floor boards along the second floor. Finish floor boards have sustained moderate-to-severe decay in a few areas, each measuring about 100 square-feet, and some areas of sub-flooring are also decayed. Photo 3 shows areas of floor that have been covered with plywood, while Photo 4 shows an area where decay has crumbled both the finish floor boards and subflooring. It appears that some mold or other fungi have begun to propagate.

**2** Water-stained and decayed wood floorboards on second floor at South end of building

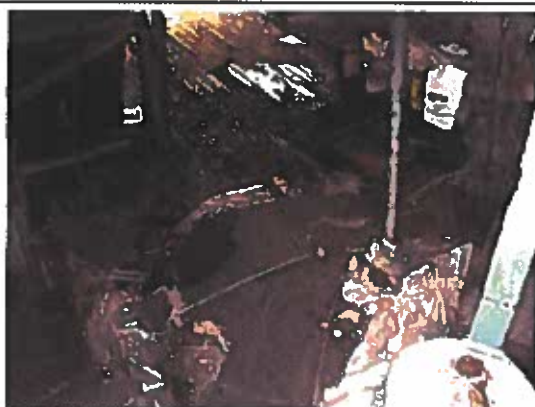
**4** Severely decayed wood flooring and sub-floor on second floor at South end of building

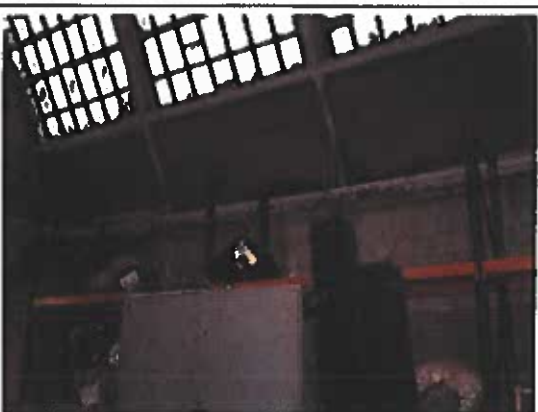
3. Water has also infiltrated many areas of the sawtooth roof system above the main factory. Photos 5 and 6 show water stains and mold growth in areas towards the South end of the building, while Photos 7 and 8 on Page 6 show several stained roof sheathing boards and other roof members near beams that support valleys of the sawtooth roof system.

**5** Water stains and mold or fungi growths below sawtooth roof towards South end of building

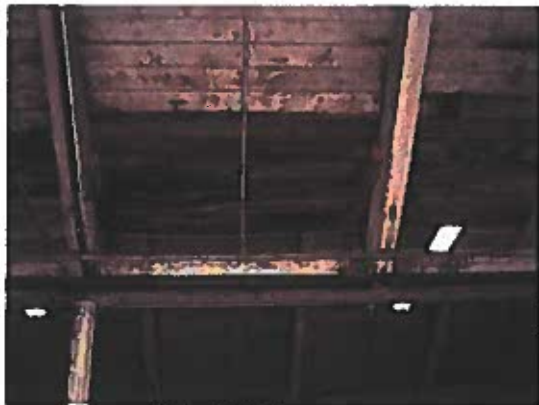
**7** Typical water-stained roof sheathing boards at valley near beam supporting sawtooth roof

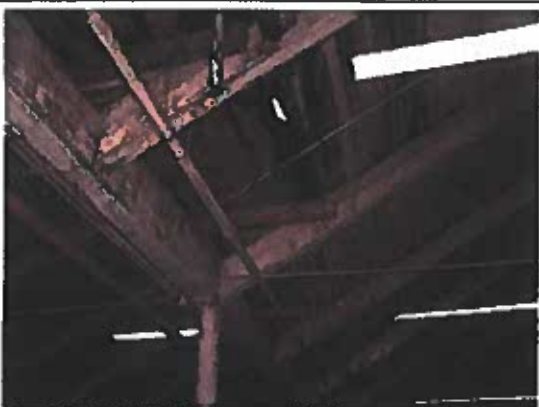
Areas of daylight can be seen through several deteriorated areas near valleys of the sawtooth roof, as shown in Photos 9 through 11; these openings in the roof would allow significant water infiltration. A plastic tarp hung above roller equipment near the North end of the building to collect water was wet during inspection of the building even though the weather was dry (see Photo 12); such continued seepage after precipitation has subsided subjects wood to prolonged exposure to wet/dry cycles that cause decay.

**9** Daylight through openings in roof sheathing boards of sawtooth roof (facing South)

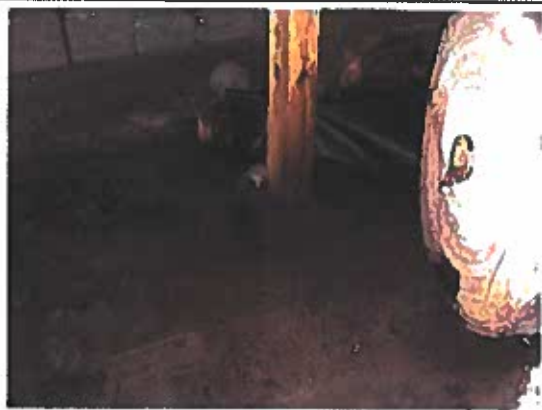
As also shown in Photo 15, the 6x6 wood posts are not properly attached to the concrete floor or supporting structural system but are instead simply propped atop the floor; further, the bottom 8" of the wood posts are waterlogged due to capillary action from surrounding puddles of standing water. As such, the entire system of beam and post bent repairs is not compliant with requirements of the building code and should not have been installed even as a temporary system of repairs.

**15** Base of wood post is waterlogged and is not connected to floor slab (facing Southeast)

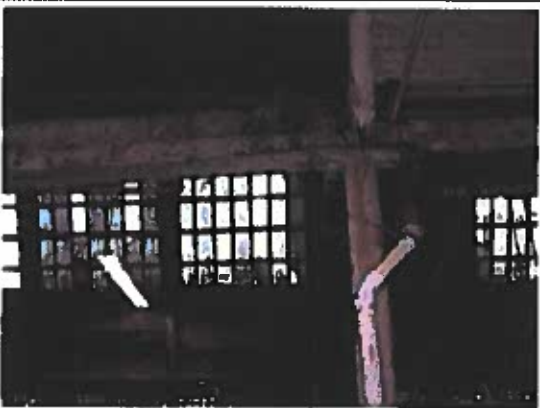
5. As shown in Photo 16, one roof support beam has been supplemented by a steel channel and diagonal brace where it frames into a wood column that is located near the middle of the factory. Such a repair is nowhere near adequate to provide load transfer to the column in lieu of the deteriorated connection, especially since the bottom of the brace is supported by a single lag screw connected to the column. As noted above, this repair system is not compliant with requirements of the building code and should not have been installed even as a temporary repair.

**16** Inadequate steel channel and brace repair at beam and column near middle of building

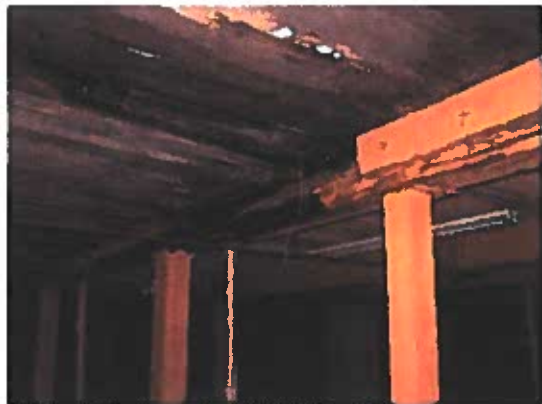
Photos 24 and 25 show another nearby beam that has sustained similar damage due to decay and presence of mold; all hazards and considerations noted above are similarly applicable to this beam. Deterioration of the wood flooring adjacent to this beam must also be investigated and addressed as noted above, as it must for the wood flooring shown in Photos 26 through 29.

**24** Decayed beam and floorboards in Southeast portion of basement (facing Northeast)

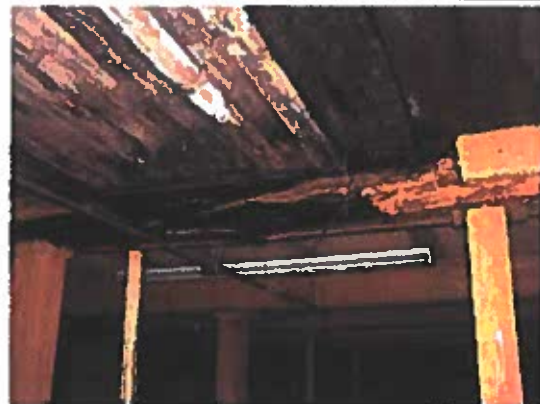
**25** Mold or other fungi contained along decayed beam shown in Photo 24 (facing East)

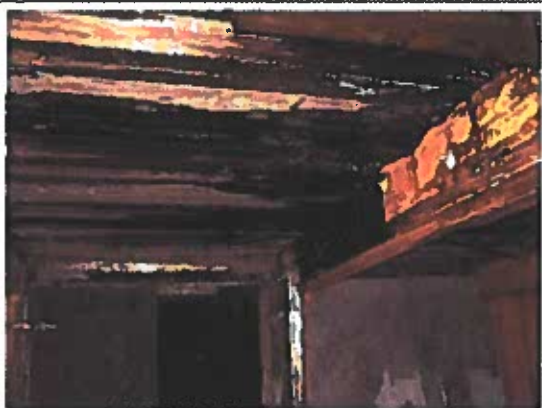
**26** Decayed wood floorboards and beam near interior wall in basement (facing North)

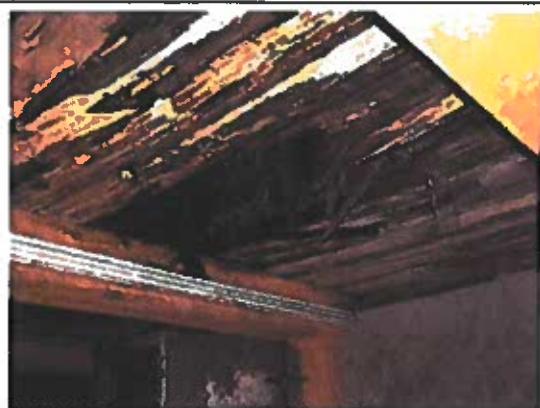
**27** Decayed wood floorboards near East side of beam shown in Photo 26 (facing Northwest)

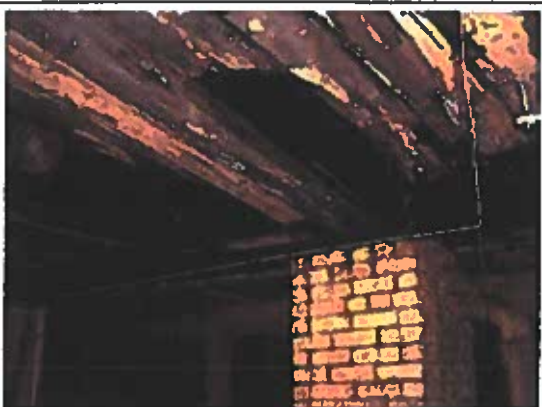
**28** Severely decayed wood floorboards at brick pillar in basement (facing Southwest)

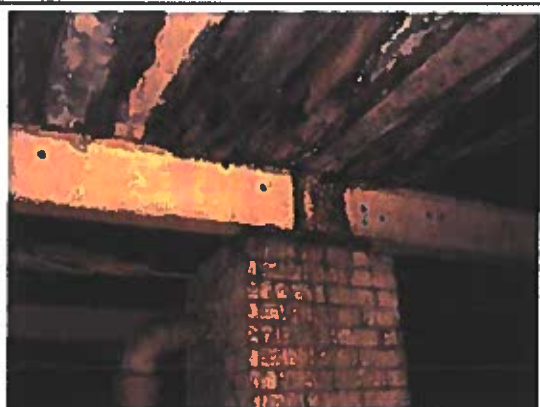
**29** Severely decayed wood floorboards at brick pillar in basement (facing Southeast)

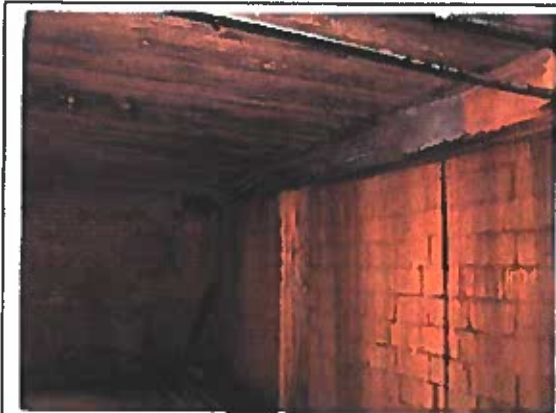
Photos 18 and 19 show a wood beam that has completely decayed away along its span between the South

wall of the building and the adjacent column where it abuts a CMU wall that is located under the machine shop area on the first floor of the building. Subject to potential disclaimers due to unknown conditions, a general conclusion can be inferred that this beam and the adjacent tributary area of wood flooring could be susceptible to sudden and catastrophic failure and collapse.

While it is possible that what appears to be an infill CMU curtain wall might provide some support to the wood flooring and overlaid concrete slab behind the wall, this decayed beam is what supports the original wood flooring that is sandwiched between the beam and the concrete slab that overlays the wood flooring. As such, any loss of this or other beams or wood flooring will adversely affect the concrete slab and may similarly affect the structural systems above the first floor slab. Once such deterioration creates gaps in any portion of the load path through the structural systems from the roof to the basement, failure mechanisms at these areas could lead to localized collapses or even progressive collapses of adjacent building areas.

**18** Decayed wood beam and floorboards near South wall of basement (facing Southwest)

Prior to commencement of in-depth evaluation and repairs, I recommend that the building owner cordon off and remove equipment from areas of the machine shop that are located over the failed beam shown in Photos 18 and 19. The owner should also address the holes that have been drilled through the concrete floor slab to facilitate drainage of water that pools on the slab; holes should be filled and the water otherwise removed, or drainage through the slab should be channeled away from wood beams and flooring in the basement in order to prevent exacerbation of wood decay. Even if some drains might be required after water infiltration through the building envelope is arrested, they must be properly installed in order to prevent such wood decay as well as to prevent damage to the concrete slab.

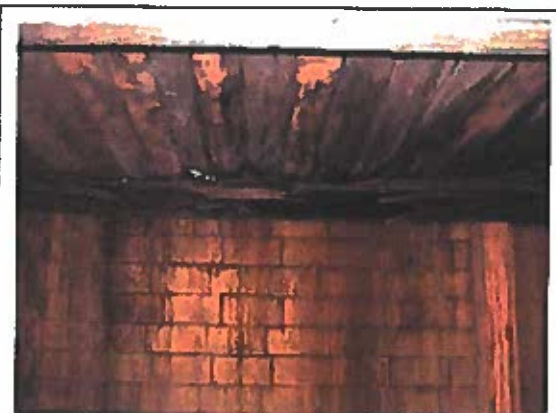
**19** Decay has completely disintegrated the wood beam shown in Photo 18 (facing West)

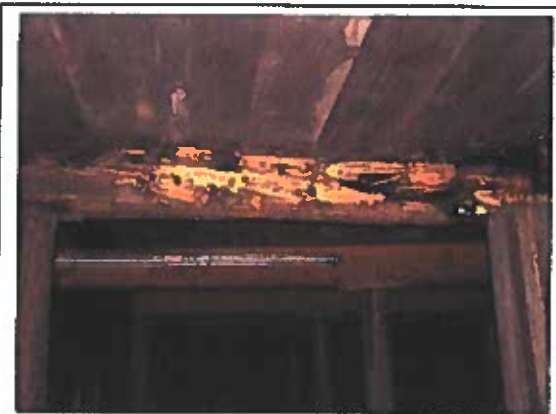
7. Photos 20 through 23 show a beam that has sustained shear failure on both sides of a column that is located about 40-feet northeast of the beam noted above. In addition to inadequate capacity to transfer load to the column, much of the width and depth of the beam has completely decayed away along the first two-feet on the North side of the column (right side shown in photos). In addition to the existence of the same hazards noted in Item 6 above, decayed areas of the beam are wet and appear to be full of mold or other fungi. This could pose a serious health hazard, not only in the basement but also throughout the entire building.

**20** Shear failure of beam at South side of column near South end of basement (facing West)

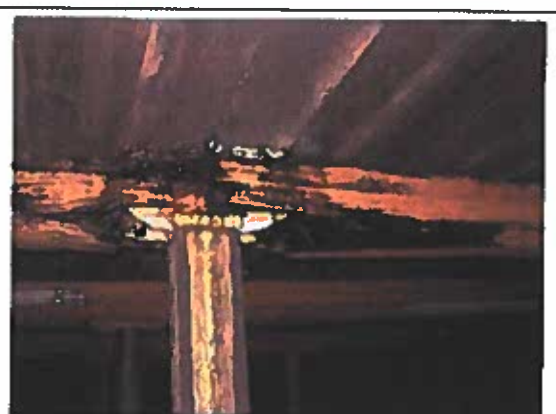
**21** Decay and shear failure of beam at North side of column shown in Photo 20 (facing West)

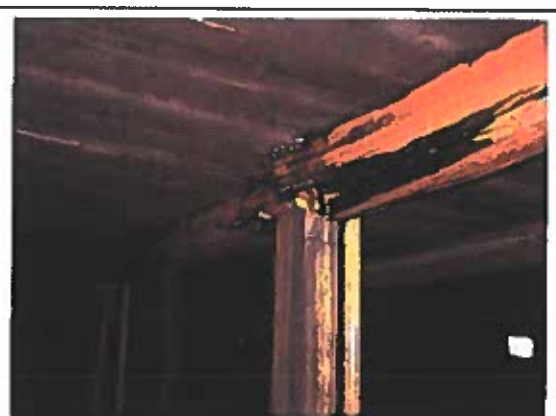
**22** Decay and shear failure of beam at column shown in Photo 20 (facing Southwest)

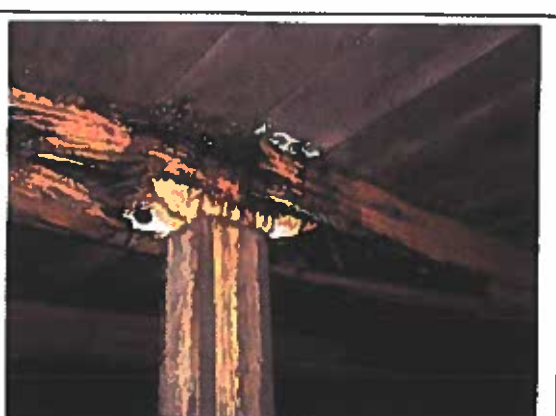
**23** Decayed beam shown in Photo 20 contains mold or other fungi (facing Northwest)

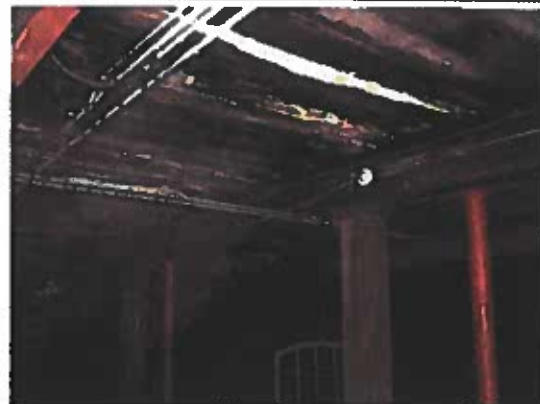
As shown in Photos 30 through 32, areas of the remaining wood flooring and beams are decayed to various degrees and it appears that mold or other fungi is growing. All hazards and considerations noted above are similarly applicable to wood flooring and beams located in this part of the basement. As shown in Photos 33 through 35, areas of the steel pans and pipe columns have corroded to various degrees; several areas of the pipe column shown in Photo 35 have completely corroded away, allowing penetration by a screwdriver. These conditions will likely worsen over time since areas along the underside of the pans were wet during inspection. While some of the white stains along the pans may be attributable to seepage of chlorides from the concrete slab above, it appears that at least some areas might be growths of mold or other fungi. Mold or fungi has grown over and around a piece of wood atop the basement floor; covering an area that exceeds 2-feet by 4-feet, it is located under the office area near the West side of the building. This very crystalline growth is bright white with pronounced tentacle-like hyphae around its perimeter, indicating the growth is likely very active. As noted above, this health hazard must be remediated.

**31** Wet and decayed wood floorboards contain mold or other fungi

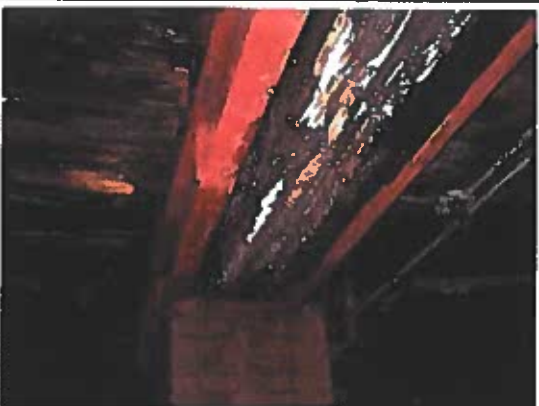
**32** Severely decayed wood beam supplemented by steel beams at pillar shown in Photo 30

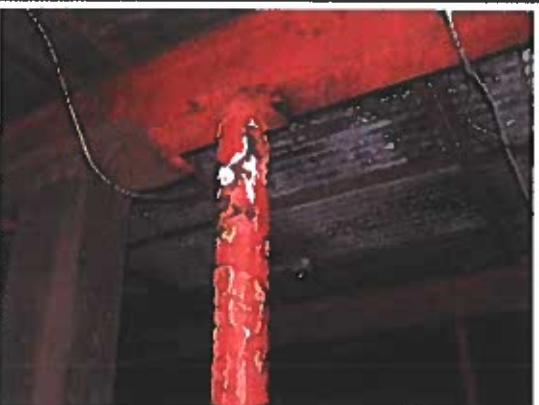
**34** Corrosion along top of steel pipe column near steel beam and along bottom of steel forms

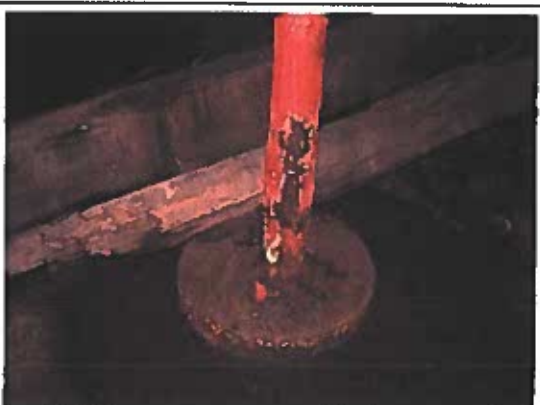
**35** Corrosion along bottom of steel pipe column near concrete footing

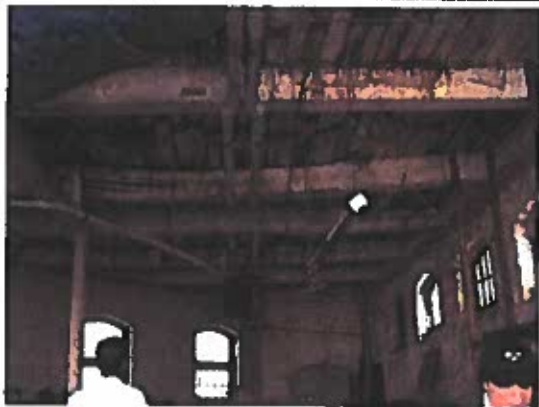
**1** Failure of roof rafter beam over second floor near Northwest corner of building

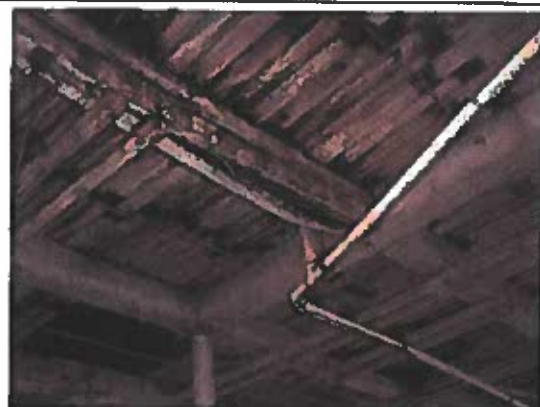
**2** Ongoing failure of another roof beam in an area near the beam shown in Photo 1

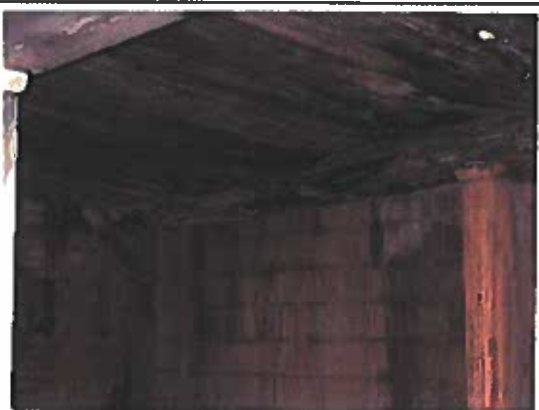
**3** Decayed wood beam disintegrating under machine shop near NW corner of building

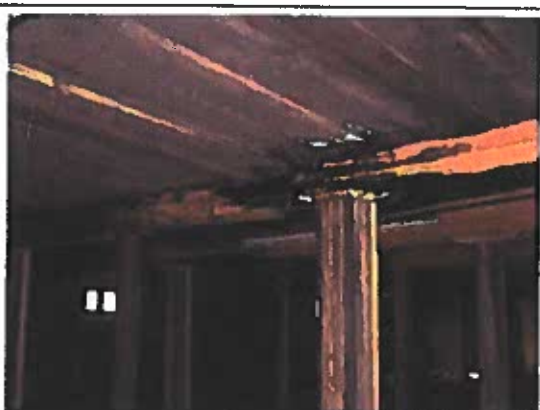
**4** Decay and shear failure of wood beam at a column near the beam shown in Photo 3

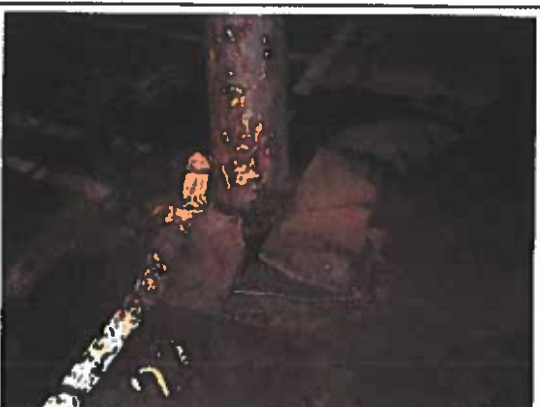
**6** Close-up of damaged concrete slab at base of column shown in Photo 5 (left side of photo)

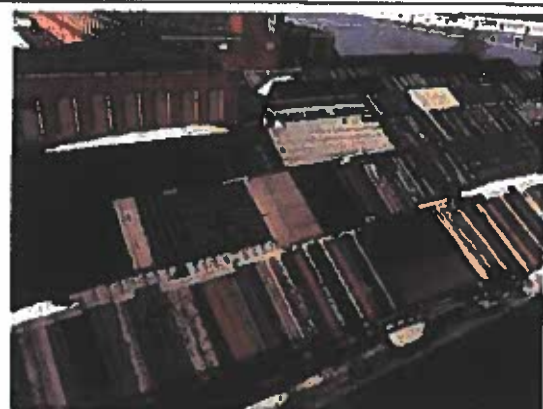
**2** North and Northeast areas of sawtooth roof (Facing Northeast)

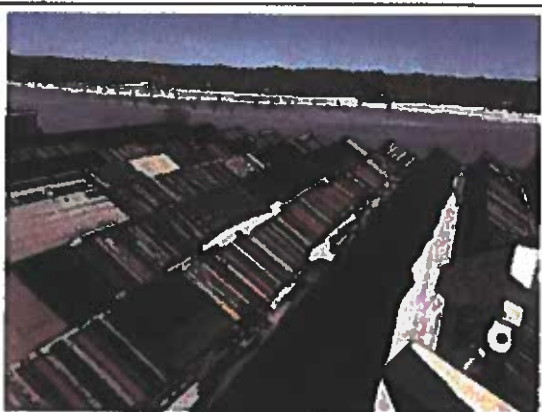
**3** Center and Northeast areas of sawtooth roof (Facing East-Northeast)

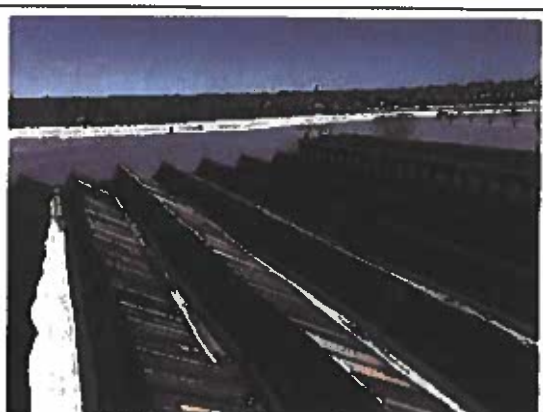
**4** Center and Southeast areas of sawtooth roof (Facing East-Southeast)

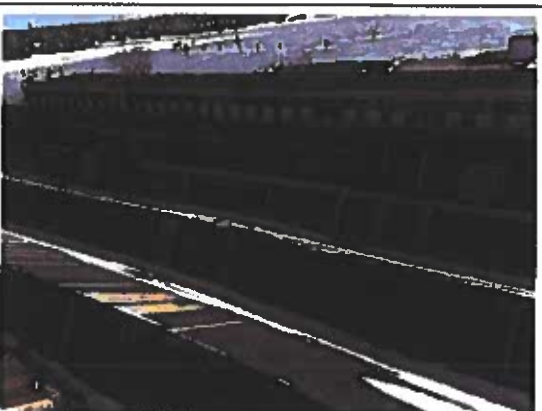
**5** Center and Southeast areas of sawtooth roof (Facing Southeast)

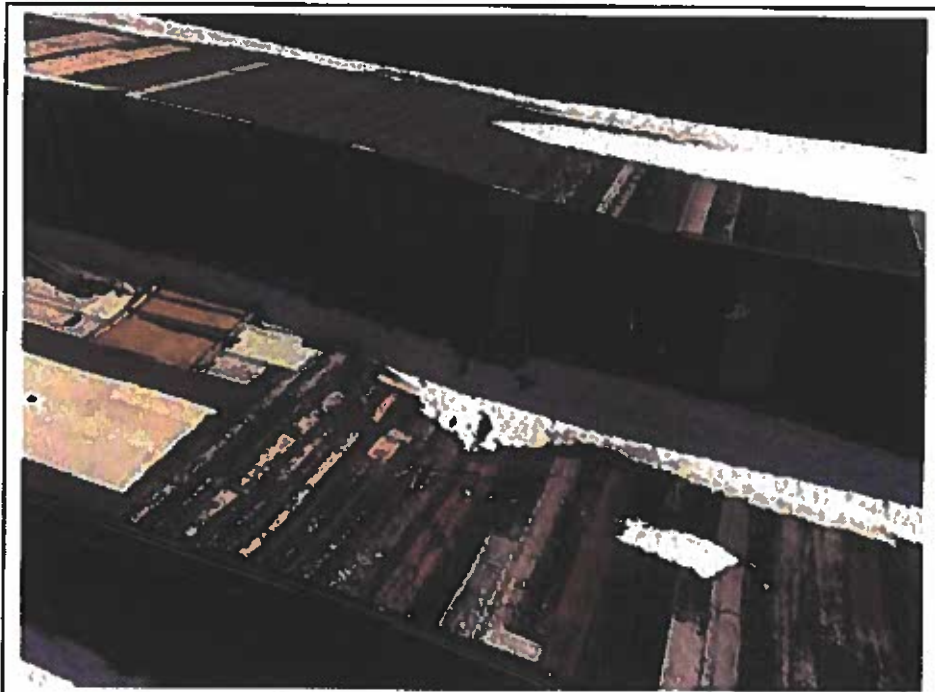
**7** Hole through sagging roof is near middle of the 9<sup>TH</sup> sawtooth gable from the North end of the building and the adjacent peak of the 10<sup>TH</sup> gable is sagging (facing South)

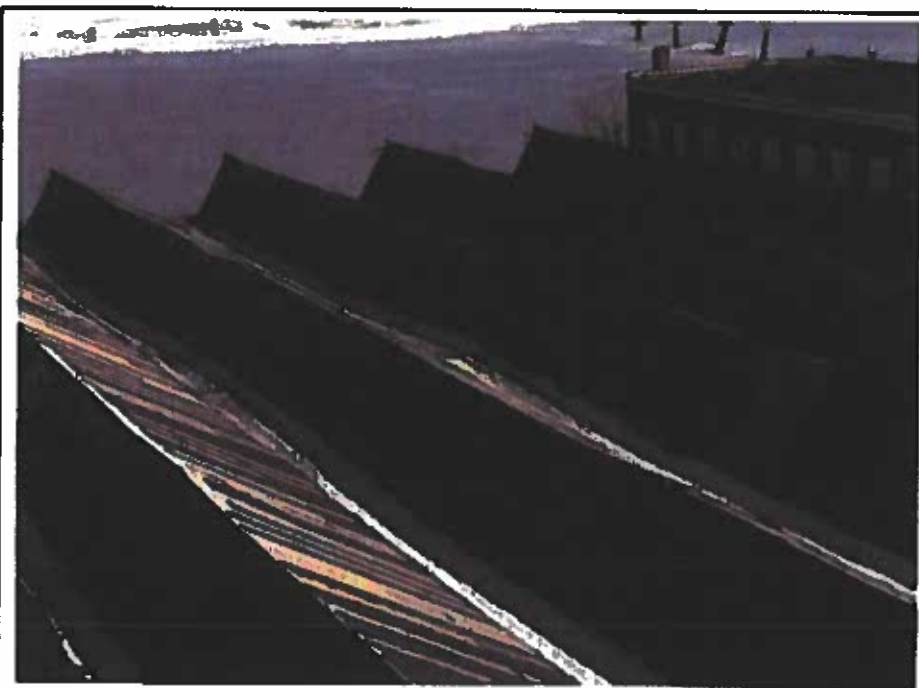
**8** Zoom of Photo 4 shows peaks of sawtooth gables at Southeast corner of building that are misaligned and out of level along their lengths (facing East-Southeast)
