Subject: 91-93 Adams Street, New Bedford, MA
Damages From July 22, 2017 Fire

INSPECTION OF BUILDING AT 91-93 ADAMS STREET, NEW BEDFORD, MA

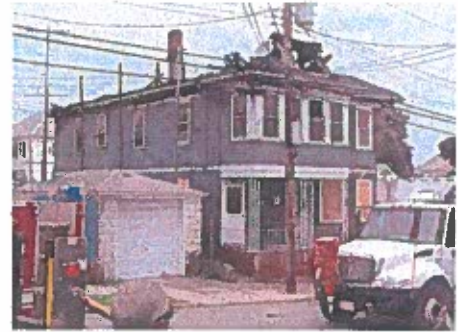
FRONT ELEVATION – FACING NORTHEAST

As shown in the photo above, the entire roof of the building collapsed due to the fire. Photos 1 through 6 on Page 2 herein show that both exterior and interior wall studs and framing components were also severely charred by fire. While you and I observed many areas of compromised wall framing during our exterior inspection, Photos 5 & 6 are among various photos provided by the insurance adjuster company Marinilli Associates that indicated similar damages were prevalent inside other areas of the building.

A summary of conditions is that several major structural components and systems of the building have collapsed or have been severely compromised beyond feasibility of repair. Since the building remains open to the weather, these components are susceptible to further deterioration that could result in further collapse. Loose material atop the roof that could become airborne debris further renders the building unsafe since it could endanger the safety of people in the vicinity of the building. I accordingly recommend that the subject building be demolished as soon as possible.

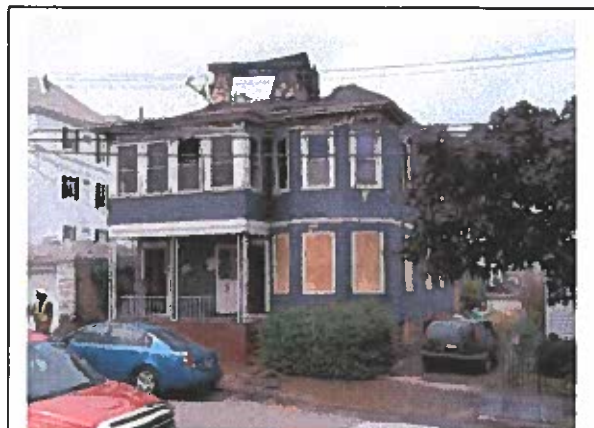
Several photos of the subject building that I obtained on February 3, 2020 indicate that conditions are essentially unchanged since the July 22, 2017 fire. Photos 7 & 8 on Page 3 herein show that the attic dormer at the front of the building has collapsed downward a little more since the fire, but that all other conditions are the same as they were 2½ years ago on the day of the fire. Photo 9 shows that the current conditions along the left side of the building are essentially identical to those shown in the photo above. And Photo 10 shows that three second floor windows along the right side of the building have been removed and the openings remain uncovered.

7 Front elevation of building on July 22, 2017 after fire extinguished

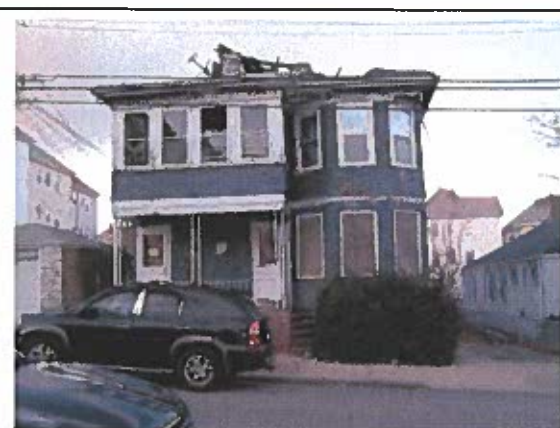
8 Elevation of building on February 3, 2020 shows conditions similar to Photo 7

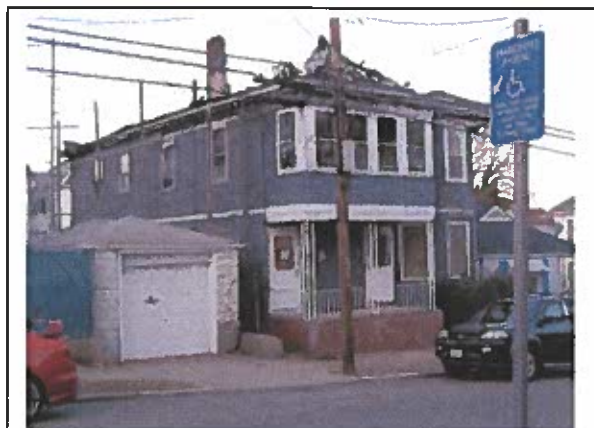
9 February 3, 2020 photo shows conditions similar to photo on Page 1 of this document

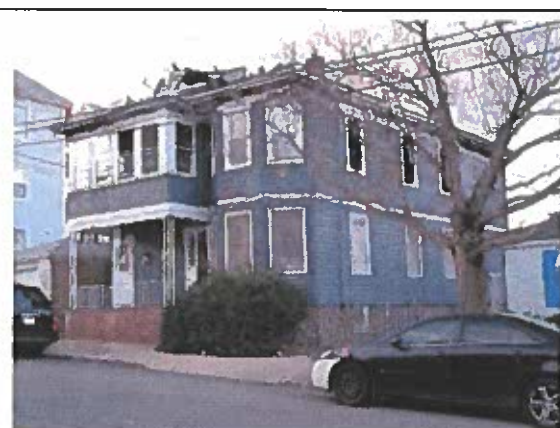
10 February 3, 2020 photo shows second floor windows open to the weather
