**RE: BUILDING DEMOLITION REVIEW**  
**1 Rear Coffin Avenue (Map 100 Lot 117) Circa 1902 masonry mill building**

**SURVEY BOARD REPORT FOR 1 R COFFIN AVENUE, NEW BEDFORD, MA**

**INSPECTION REPORT FOR 1 R COFFIN AVENUE, NEW BEDFORD, MA**

**BUILDING ROOF SURVEY AT 1 R COFFIN AVENUE, NEW BEDFORD, MA**

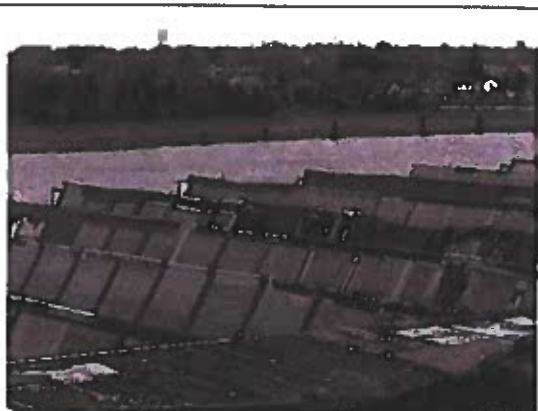
Photos 1 through 3 on Page 2 herein are presented in a panoramic sweep from East-to-Southeast-to-South in order to provide acclimation to the roof layout and show overall roof conditions, while Photos 4 through 6 show some of the peaks of sawtooth roof systems that are misaligned and out of level. Photos 7 through 9 on Page 3 show several large holes through a flat roof and expanses of sawtooth roof systems that have collapsed.

**5** Misaligned areas of sawtooth roof systems shown in Photos 1 & 2 (facing Southeast)

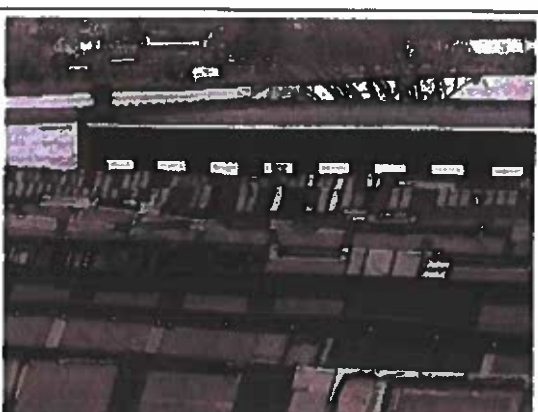
**6** Close-up of misaligned areas of sawtooth roof systems shown in Photo 2 (facing SSE)

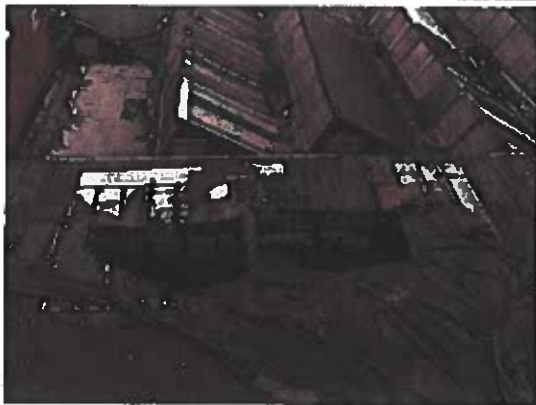
**7** Holes through roof near Northwest corner of building (facing East) – refer to Photo 1

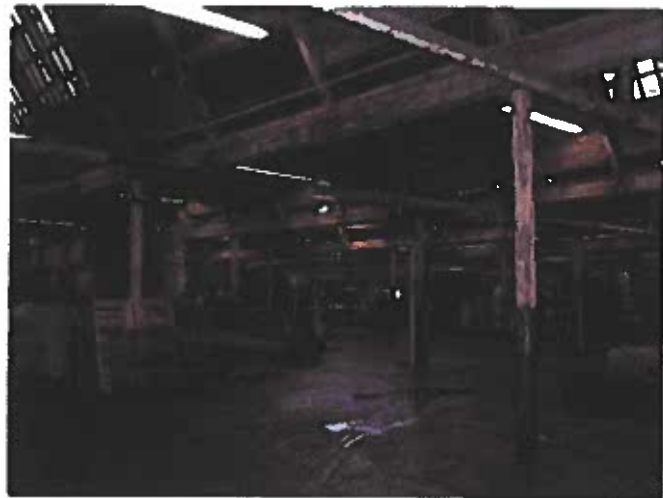
**SAWTOOTH ROOF OVER FIRST FLOOR OF BUILDING**

1. Many of the deficiencies that were observed throughout the interior of this building appear to have been caused by water infiltrating the building envelope at various locations through areas of the roof systems. As shown in the photo above, most of this mill building is comprised of a single-story factory covered by a sawtooth roof system, while a small percentage of the building area is covered by flat roofing.

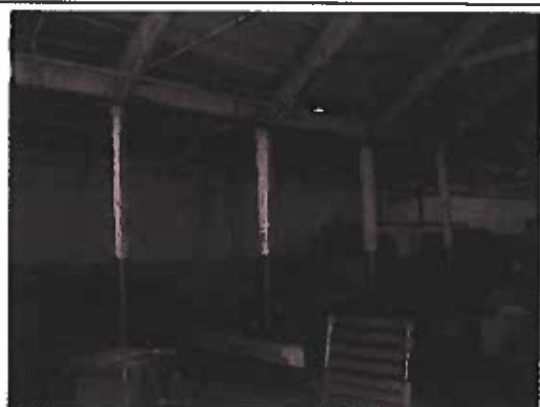
**10** Daylight through openings in roof sheathing boards of sawtooth roof (facing Southeast)

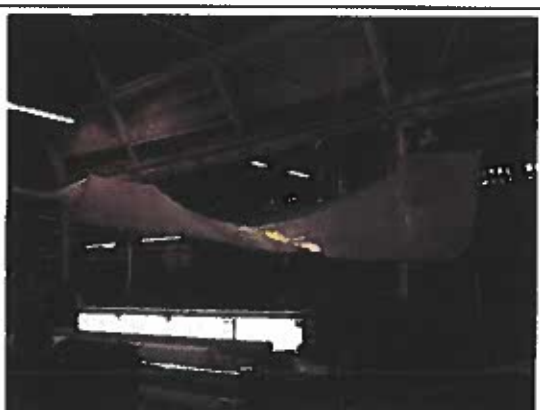
**12** Water seepage in plastic tarp hung above equipment near North end of building

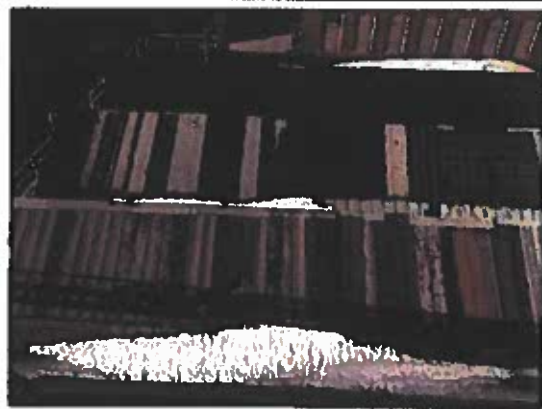
**1** Northwest corner of sawtooth roof located South of two-story ell (Facing North)
